INVESTIGATION OF WATERS OF THE UNITED STATES

CIELO GRANDE RANCH MONTEREY COUNTY, CALIFORNIA

October 26, 2006

Project Number 570-03

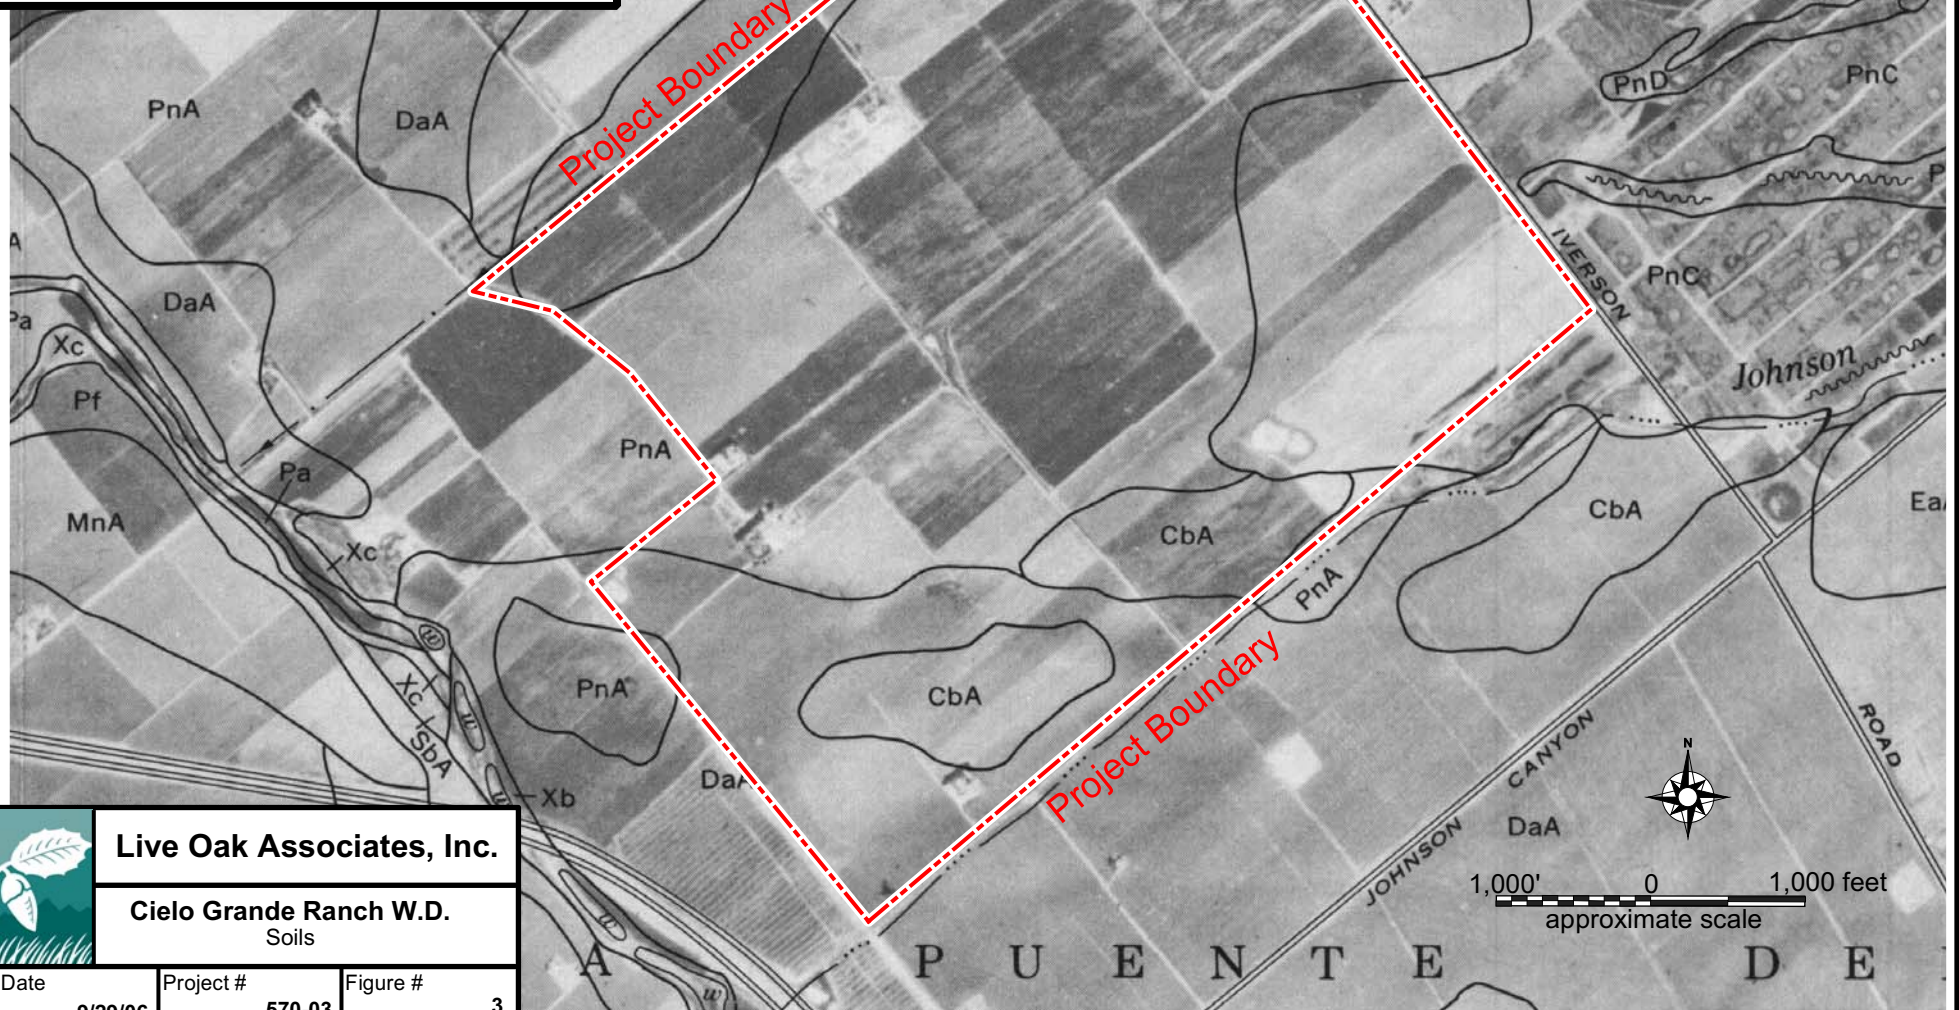
Date	Project #	Figure #	
9/29/06	570-03	3

Four soil series are represented on the site (Figure 3, Table 1). Like most soils of the Salinas Valley, the soils of the project site consist of alluvium derived primarily from granitic and schistose rock (NRCS 1978). This area has been used primarily for agricultural uses although more intense development is becoming common. Of the four soil series that occur on the site, none are considered to be hydric and only one has hydric inclusions. The Placentia sandy loam with 0% to 2% slopes, which is the dominant soil type on the project site, is not overall a hydric soil, but contains hydric inclusions where depressions are present. This means that in areas that were naturally at a lower elevation than the surrounding upland, hydric inclusions could occur. The remaining three soil types of the site are not considered to be hydric.

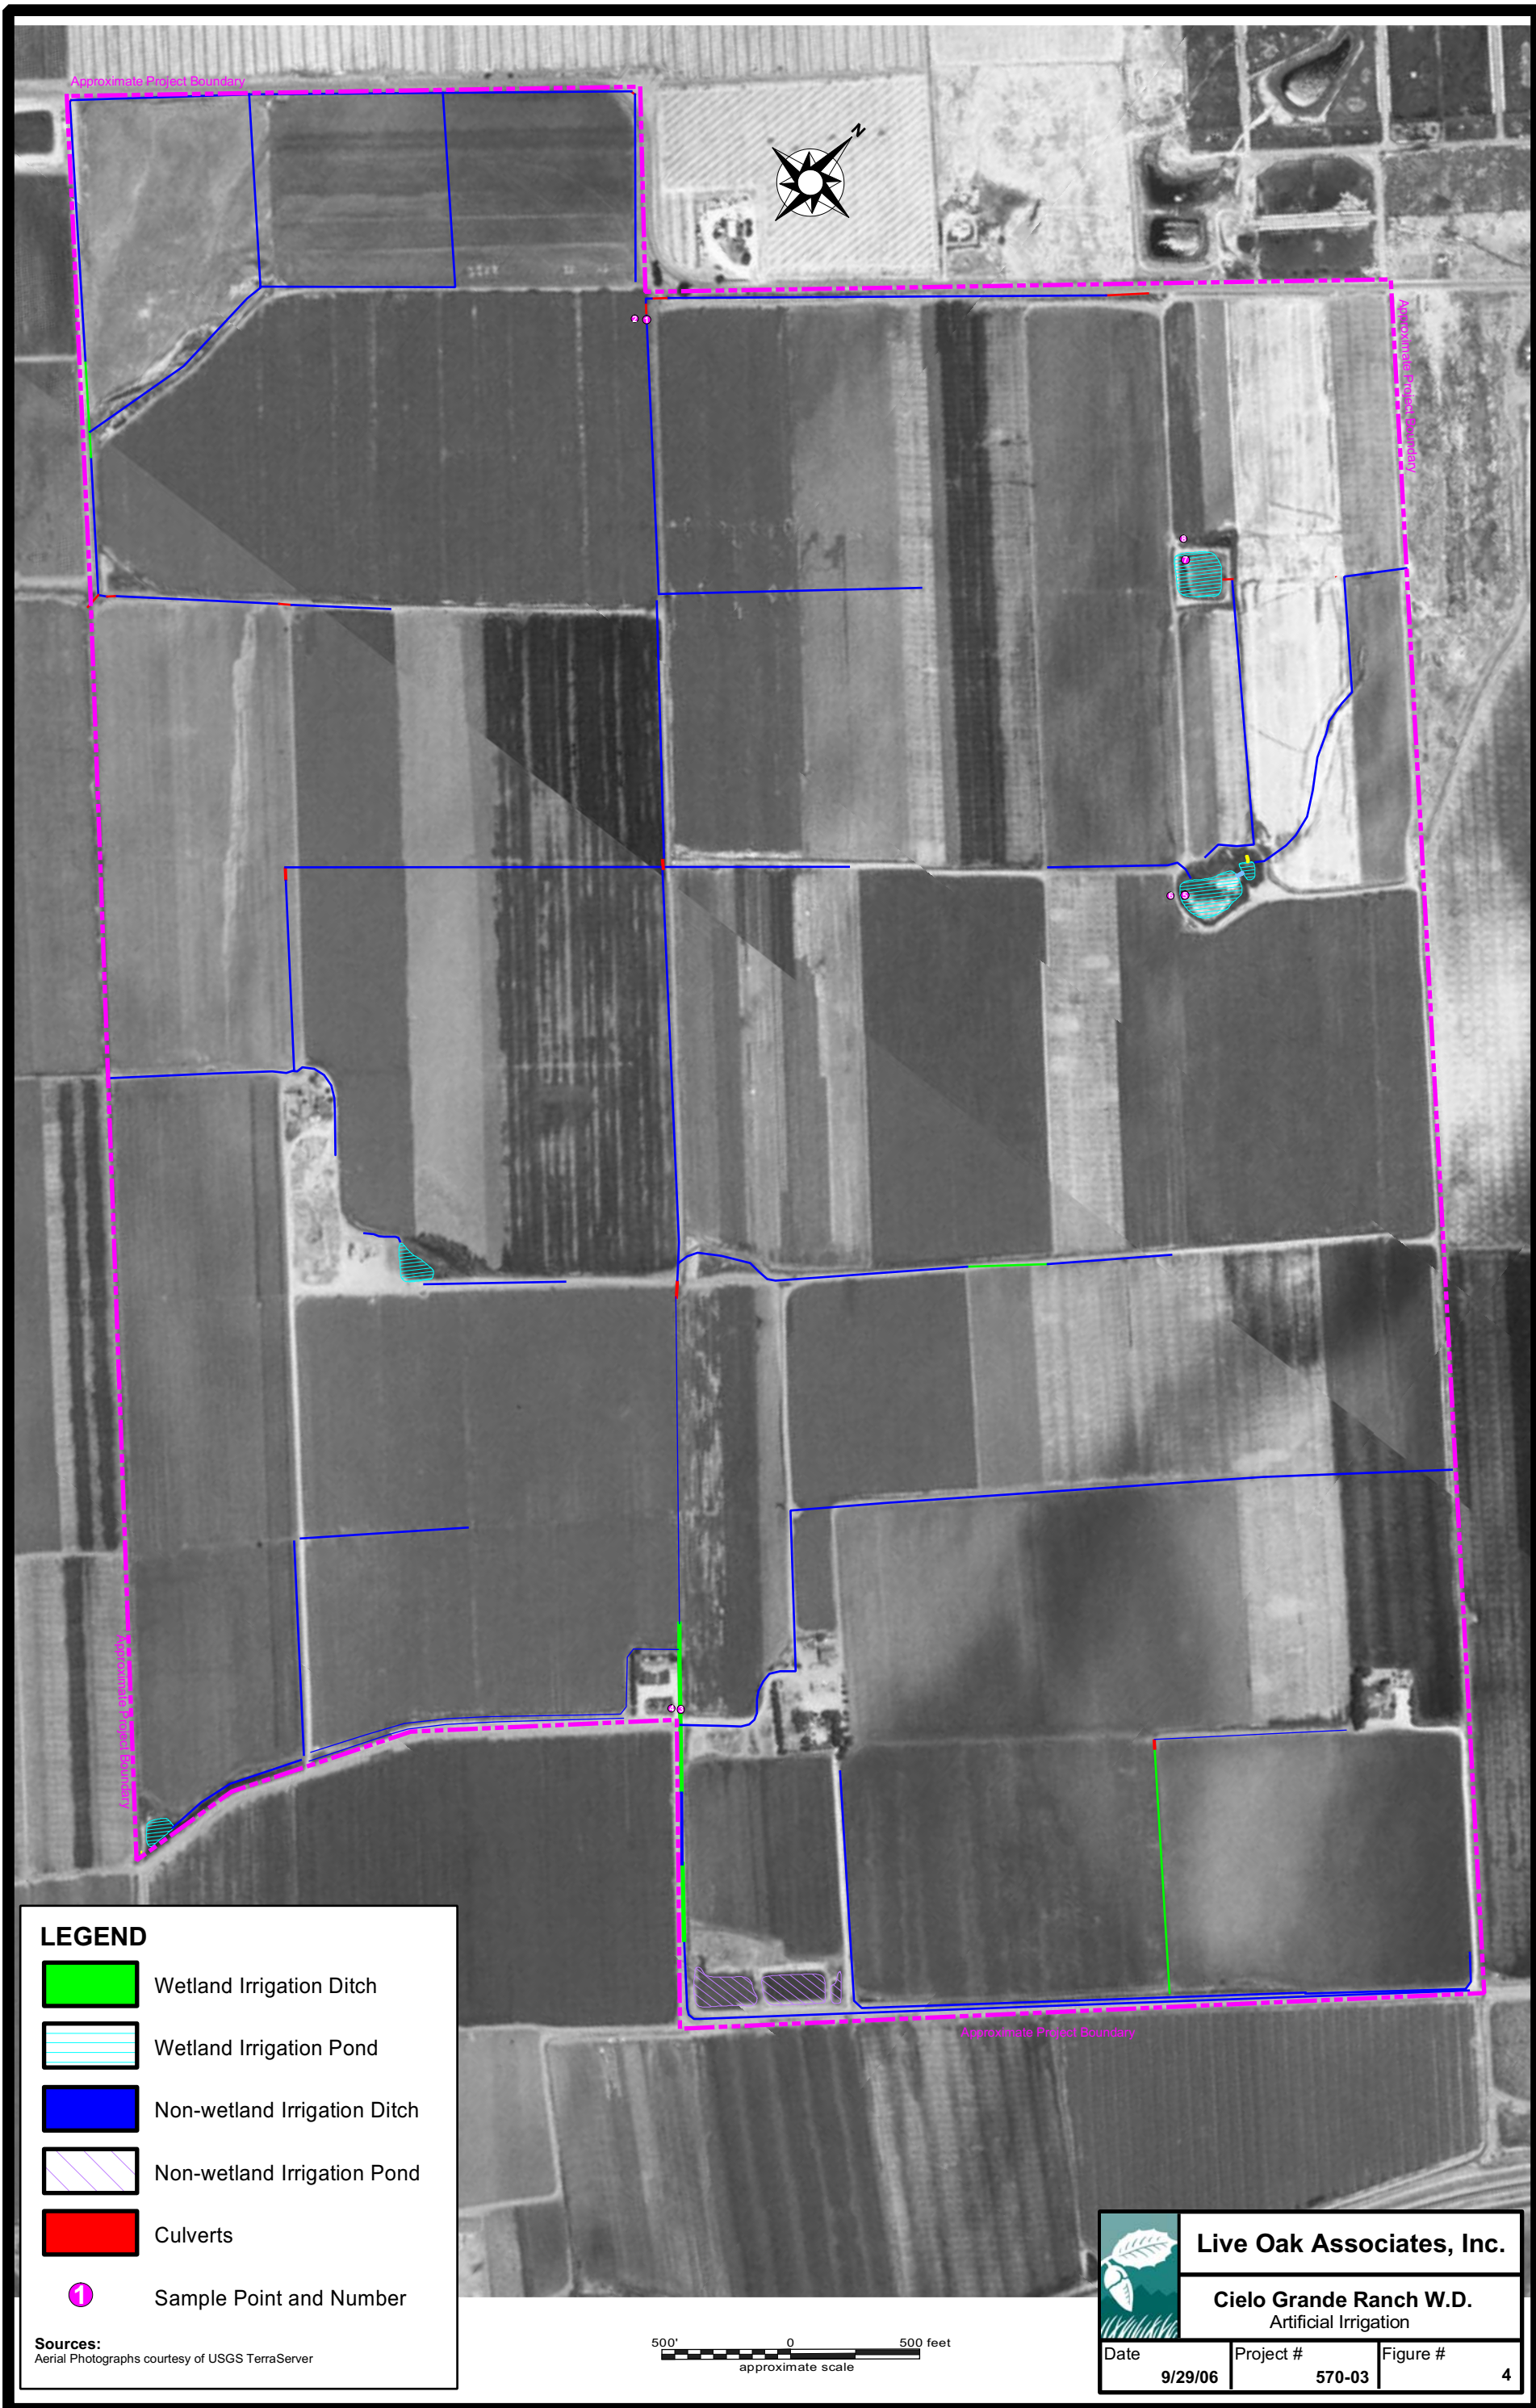
Live Oak Associates, Inc.		
	Cielo Grande Ranch W.D. Artificial Irrigation		
Date	Project #	Figure #	
9/29/06	570-03	4

The majority of the onsite features are artificial irrigation features that flow into irrigation ponds or percolate into the ground prior to flowing off the project site. During the site survey, many of these features were recorded; however, most of them shift depending on agricultural activity of the field. Therefore, these features are clearly believed to be isolated (Figure 4).

Eight representative sampling locations were selected within the study area where vegetation, hydrology and soils information were collected to document site conditions. This information was entered onto standard data sheets patterned after those used by the USACE. The data sheet for each numbered sampling location can be found in Appendix B of this report. All numbered sampling locations have been identified on the maps depicting the areas meeting the technical criteria of jurisdictional wetlands (Figures 4 and 5).

There were four isolated wetland irrigation ponds identified on site (Sample Points 5 and 7; Figure 4). These wetland irrigation ponds were fed by numerous irrigation ditches, which line the perimeter of the site's agricultural fields. These wetland irrigation ponds were dominated by barnyard grass (*Echinochloa crus-galli*)(FACW), Mexican lovegrass (*Eragrostis mexicana*)(FAC), common tule (*Scirpus acutus*)(OBL) and tall cyperus (*Cyperus eragrostis*)(FACW). Hydrology indicators present were inundation. The soils at these sample points were assumed to contain aquatic moisture regimes because they were inundated and contained between two and twelve inches of surface water. Hydric soils were met due to inundation.

There was a set of three isolated non-wetland irrigation ponds along the western boundary where Fanoe Road takes a 90° turn to the northeast (Figure 4). As with the other ponds, irrigation ditches fed them from other locations of the site. The ponds and surrounding banks were void of vegetation and highly maintained. They were inundated with greater than 12 inches of water at the time of the July 2006 survey. Due to the presence of an aquatic moisture regime, the soils were considered hydric. However, regardless of the presence of wetland hydrology and hydric soils, the vegetation criterion was not met.

The majority of the onsite features consist of non-wetland irrigation ditches that line the perimeter of the active agricultural fields (Sample Point 1; Figures 4 and 5). The majority of these ditches are temporary and created when a field is active. Most of these features are manmade and are fed by the farm's extensive, temporary irrigation systems and do not converge with any known Water of the United States. However the two large drainages that flow through the site may replace the functions and values of historic waterways. Dominant vegetation within the sampled drainage consisted of cheese weed (*Malva parviflora*)(UPL) and Mexican lovegrass (*Eragrostis mexicana*)(FAC). Other non-dominant species observed included tall cyperus (*Cyperus eragrostis*)(FACW), rabbitfoot grass (*Polypogon monospliensis*)(FACW+), spiny cocklebur (*Xanthium spinosum*)(FAC+) and hyssop loosetrife (*Lythrum hyssopifolium*)(FACW). Wetland

There are a number of wetland irrigation ditches present on site (Sample Point 3; Figures 4 and 5). The majority of these ditches are temporary and created when a field is active. Most of these features are manmade and are fed by the farm's extensive, temporary irrigation systems and do not converge with any known Water of the United States. However the two large drainages that flow through the site may replace the functions and values of historic waterways, of which a few reaches met the technical criteria of jurisdictional wetlands. Vegetation within these drainages was dominated by barnyard grass (*Echinochloa crus-galli*)(FACW), rabbitfoot grass (*Polypogon monospermius*)(FACW+) and Mexican lovegrass (*Eragrostis mexicana*)(FAC). The wetland hydrology indicator at this sample point was inundation of one inch of water. Therefore, hydric soils are assumed to be met due to an aquic moisture regime.

The upland area surrounding the delineated features has been classified as agricultural land (Sample Points 4, 6, and 8; Figure 4 and 5). Dominant species observed include tomatillo (*Physalis philadelphica var. immaculata*)(UPL) and iceplant (*Carpobrotus edulis*)(NI). Wetland hydrology indicators were absent at all these sample points. The Munsell matrix color of the soil at Sample Point 4 and 8 was 7.5 YR 2.5/2 or 10 YR 3/4, neither of which are considered to be hydric. Sample Point 6, had a Munsell matrix color of 10YR 2/2 and contained few, small red mottles which are indicators of hydric conditions. However, Sample Point 6 was not a wetland because it did not meet the hydrology and vegetation criterion.

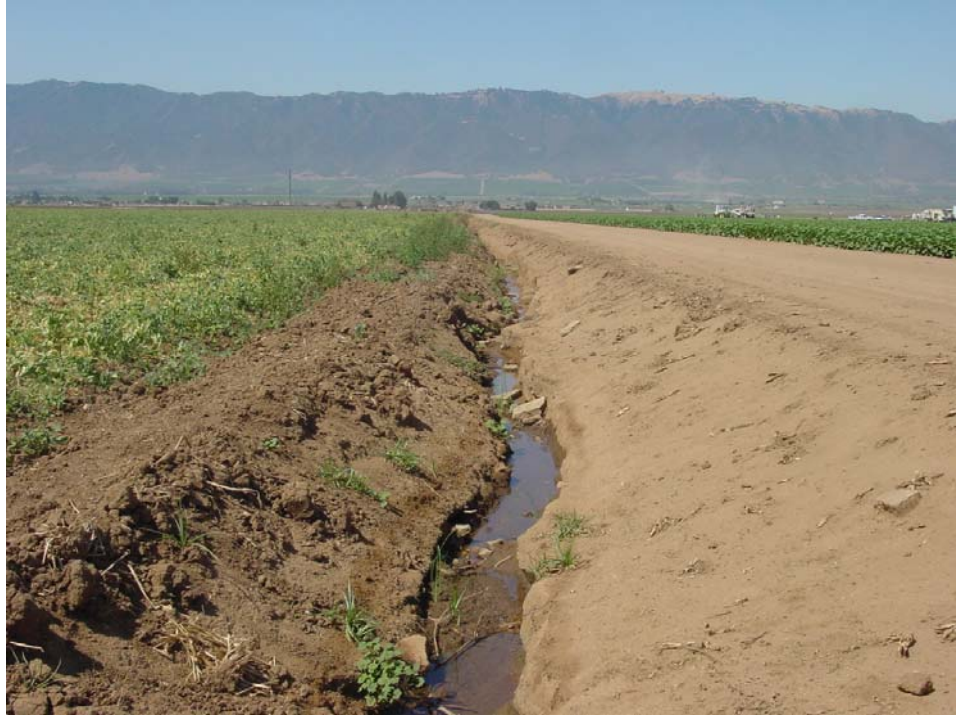
Isolated Wetland Irrigation Ditch (Sample Point 3; July 2006)

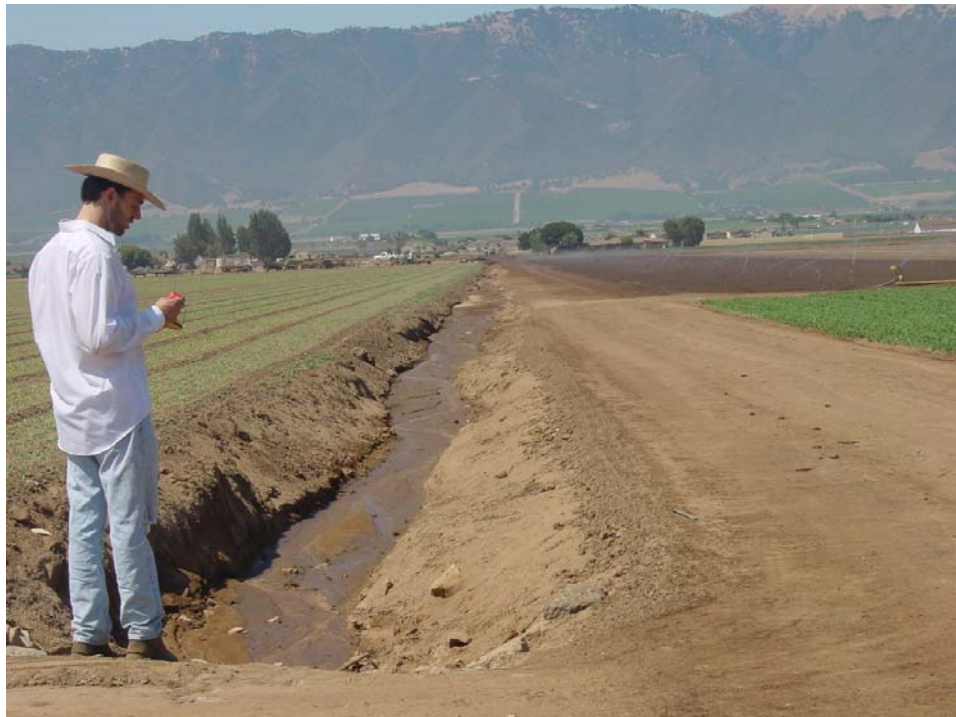
Isolated Non-wetland Irrigation Ditch (Sample Point 1; July 2006)

hydrology and hydric (aquic moisture regime) soils were present at Sample Point 1 because the ditch was inundated; however the vegetation criterion was not met.

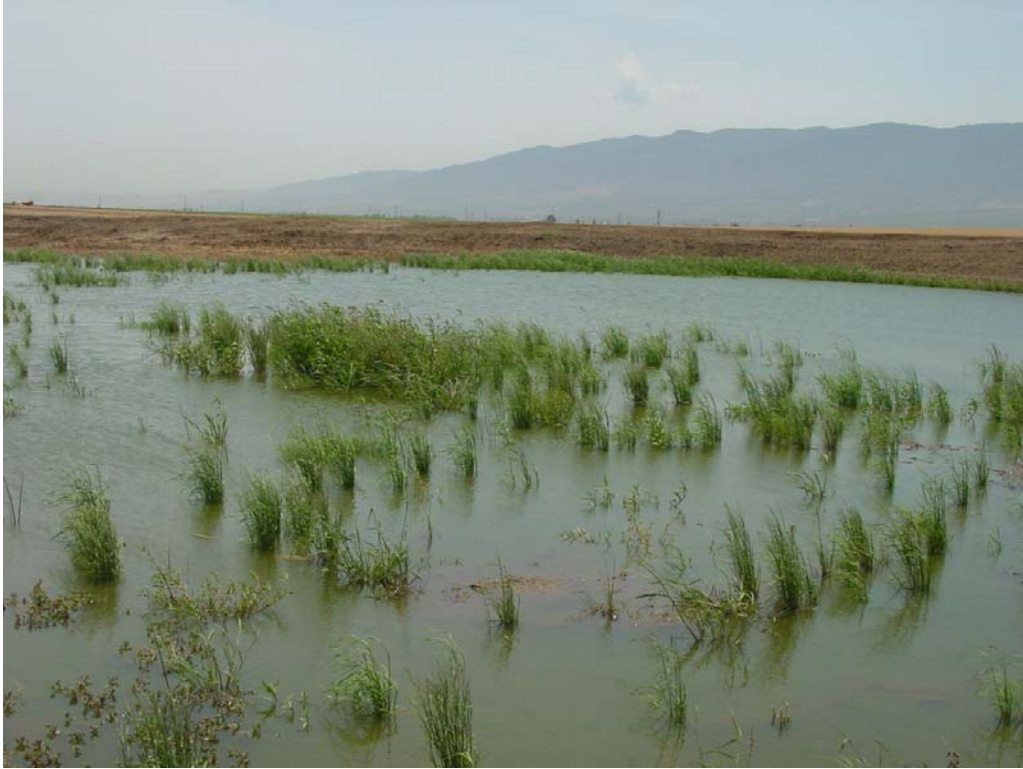
Isolated Wetland Irrigation Pond (Sample Point 6; July 2006)
