Gonzales Community Center Project

Technical Studies

**GEOTECHNICAL INVESTIGATION
GONZALES COMMUNITY CENTER
GONZALES, CALIFORNIA**

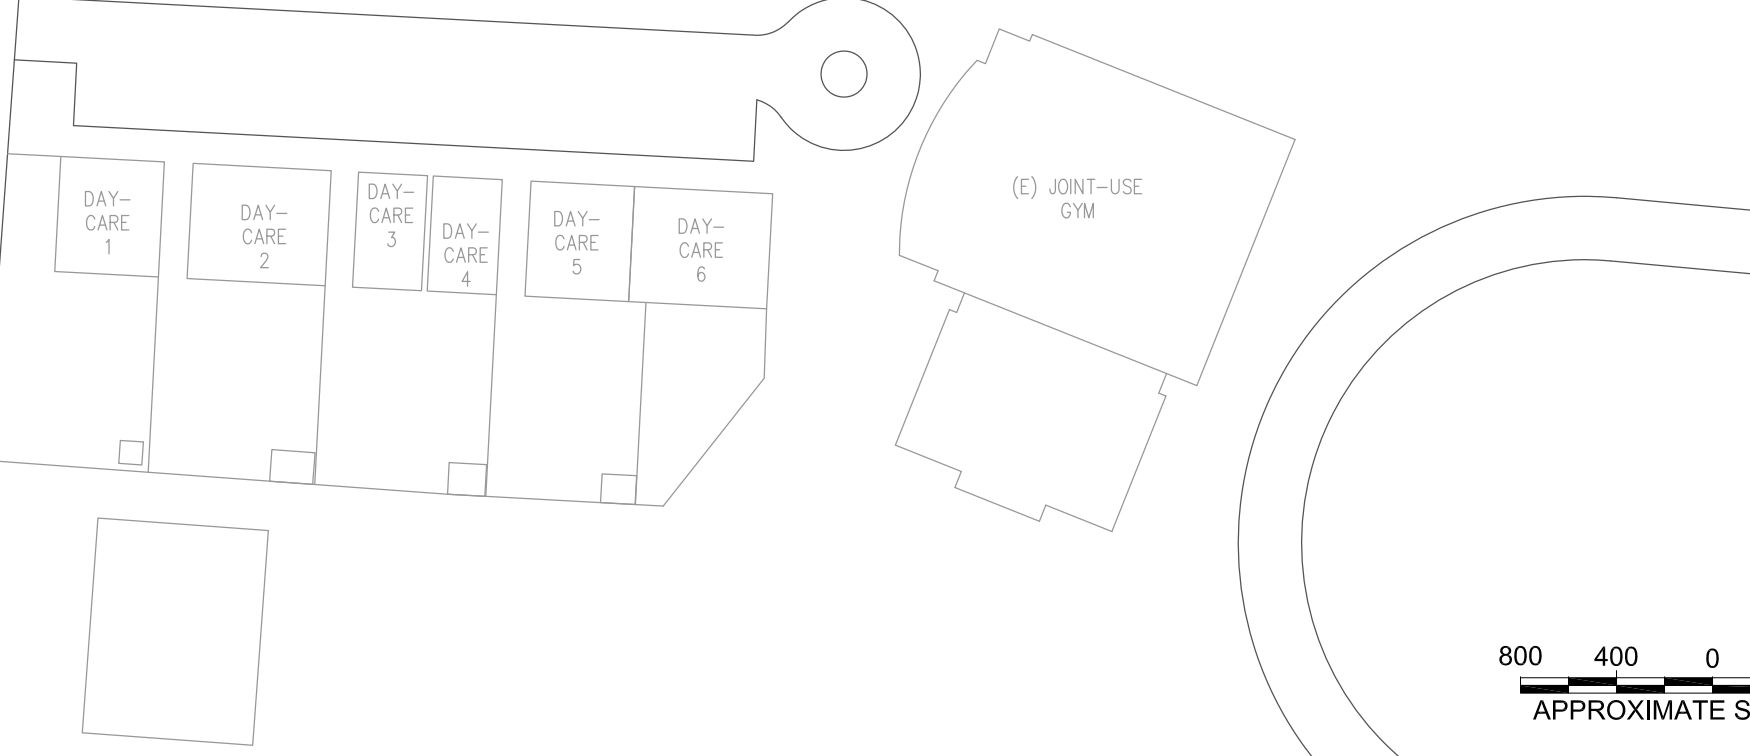
B-3 ● APPROXIMATE BORING LOCATION
 (by Kleinfelder 2012)

The above is a general description of the soil conditions encountered in the six borings performed for this investigation. For a more detailed description of the soil conditions encountered, please refer to Appendix A for the borings presented on Plates A-4 through A-9.

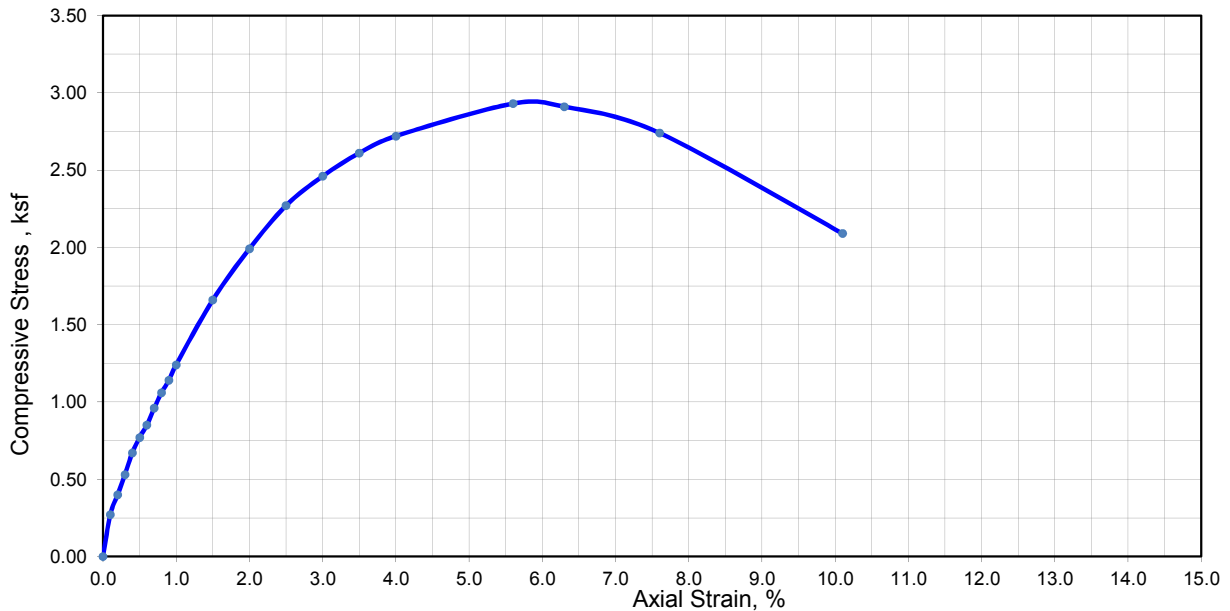
Unconfined Compression Test Report

Specimen Failure Picture	Specimen No.		1	
	Initial	Diameter, in	D ₀	2.40
		Height, in	H ₀	5.85
		Water Content, %	ω ₀	14.6
		Dry Density, lbs/ft ³	γ _{d0}	117.5
		Saturation, %	S ₀	95.0
		Void Ratio	e ₀	0.407
	Time to Failure, min.	t _f	5.0	
	Unconfined Compressive Strength, ksf	q _u	2.93	
	Shear Strength, ksf	s _u	1.46	
	Strain at Failure, %	ε _f	5.6	
Average Rate of Strain to Failure, %/min	ε	1.0

Description of Specimen: Brown Clayey Sand (SC)

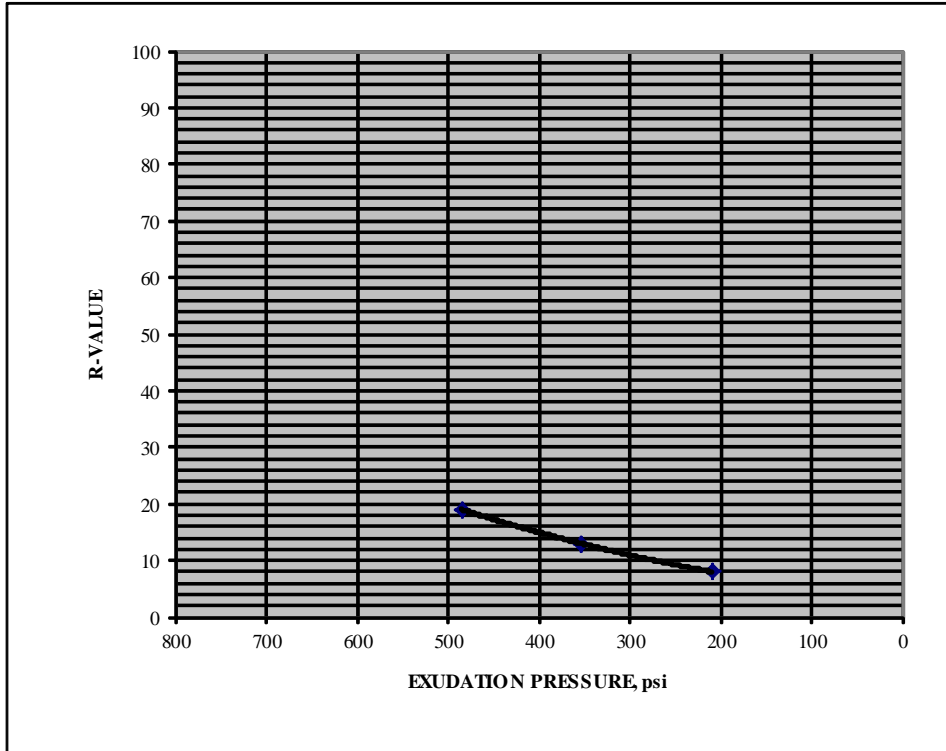
Project Name: GONZALES COMMUNITY CENTER
Project No.: 127923
Lab No.: HL4548
Sample No.: B-1 @ 0.0' - 5.0'
Material Description: Gray-Brown Silty SAND (SM)
Report Date: June 27, 2012

Specimen No.	A	B	C
Moisture at Test, %	11.0	11.9	10.0
Dry Unit Weight at Test, pcf	125.6	122.2	123.1
Expansion Pressure, psf	48	0	134
Exudation Pressure, psi	353	210	485
Resistance Value	13	8	19

EXPANSION PRESSURE AT 300 PSI EXUDATION PRESSURE, psf	25
R - VALUE AT 300 PSI EXUDATION PRESSURE	11

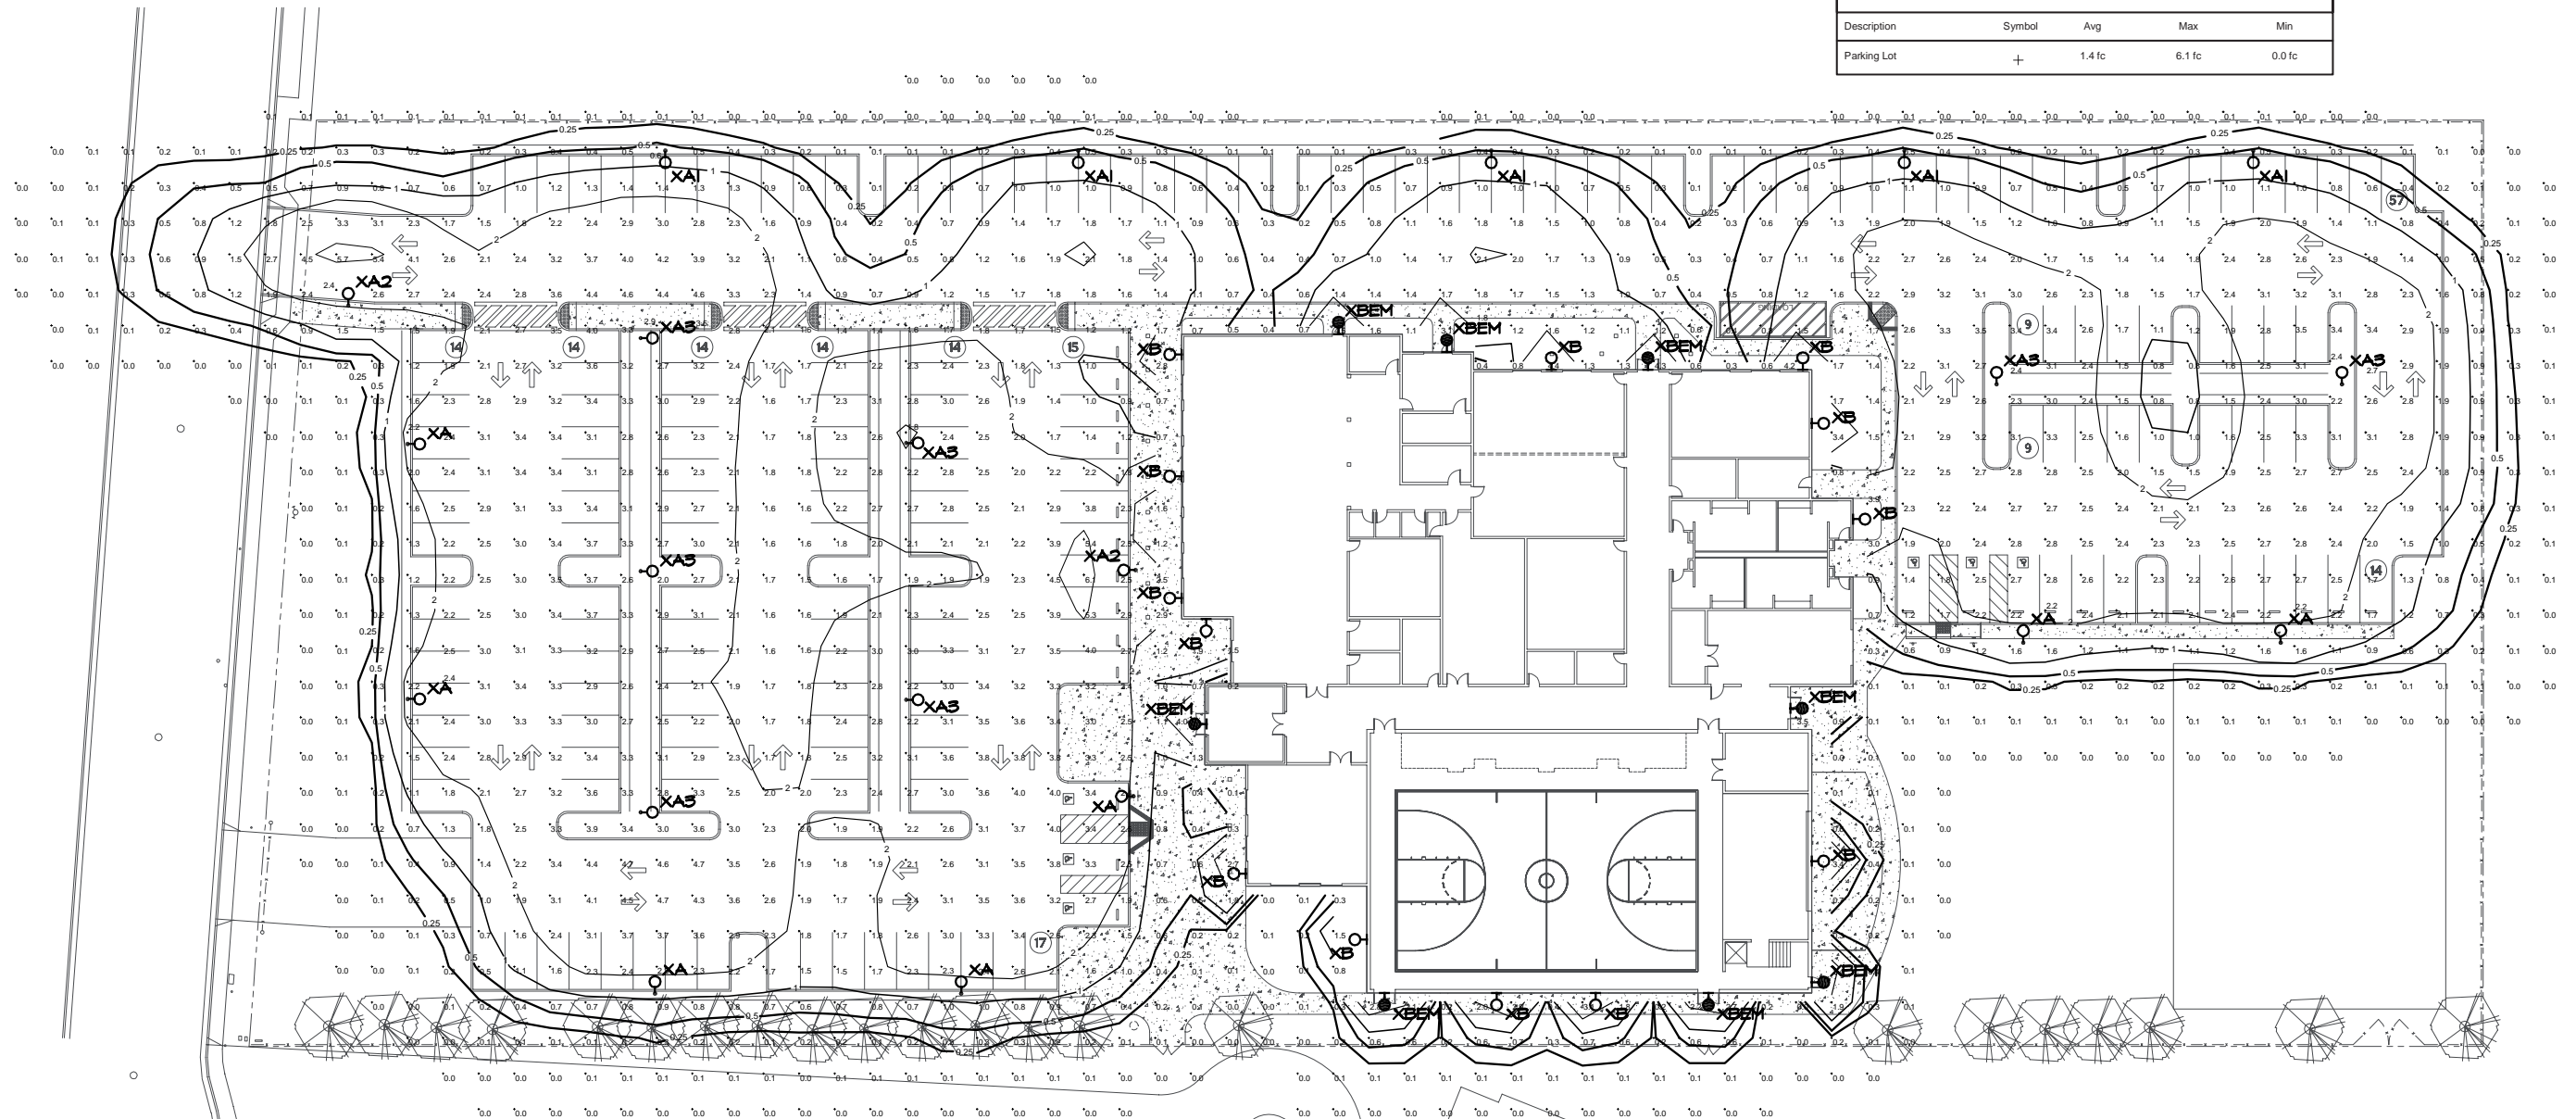
Photometric Site Plan

STATISTICS				
Description	Symbol	Avg	Max	Min
Parking Lot	+	1.4 fc	6.1 fc	0.0 fc
