Environmental Hazards Reports

**Phase I and Phase II  
Environmental Site Assessment**  
Fanoe Ranch  
Gonzales, California

November 2, 2004  
Project No. 1989-1B

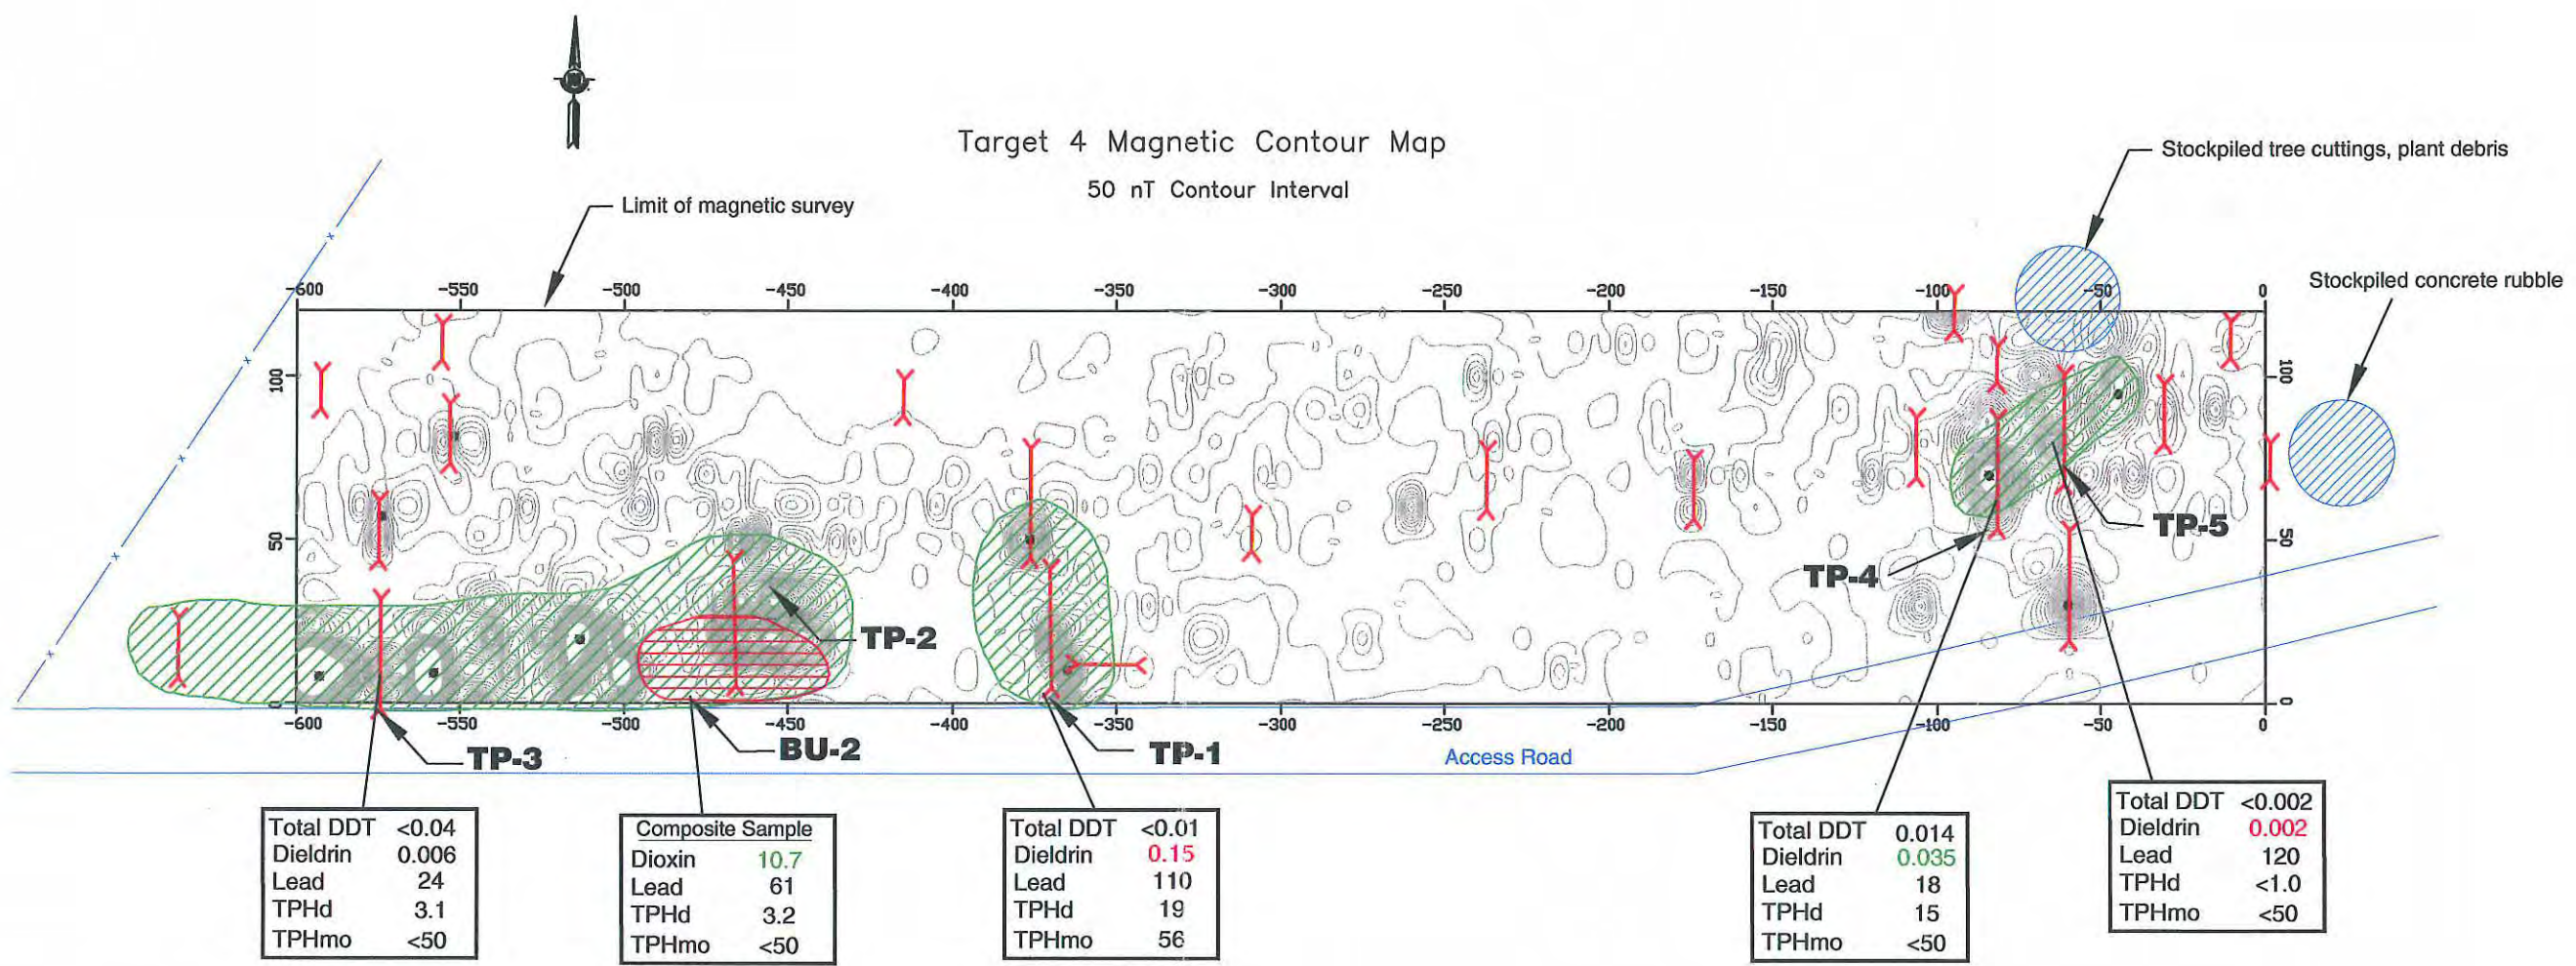
**FIGURE 7**  
1989-1B

- Approximate location of exploratory trench (See Appendix H)
- Approximate extent of buried debris
- Approximate extent of burn area

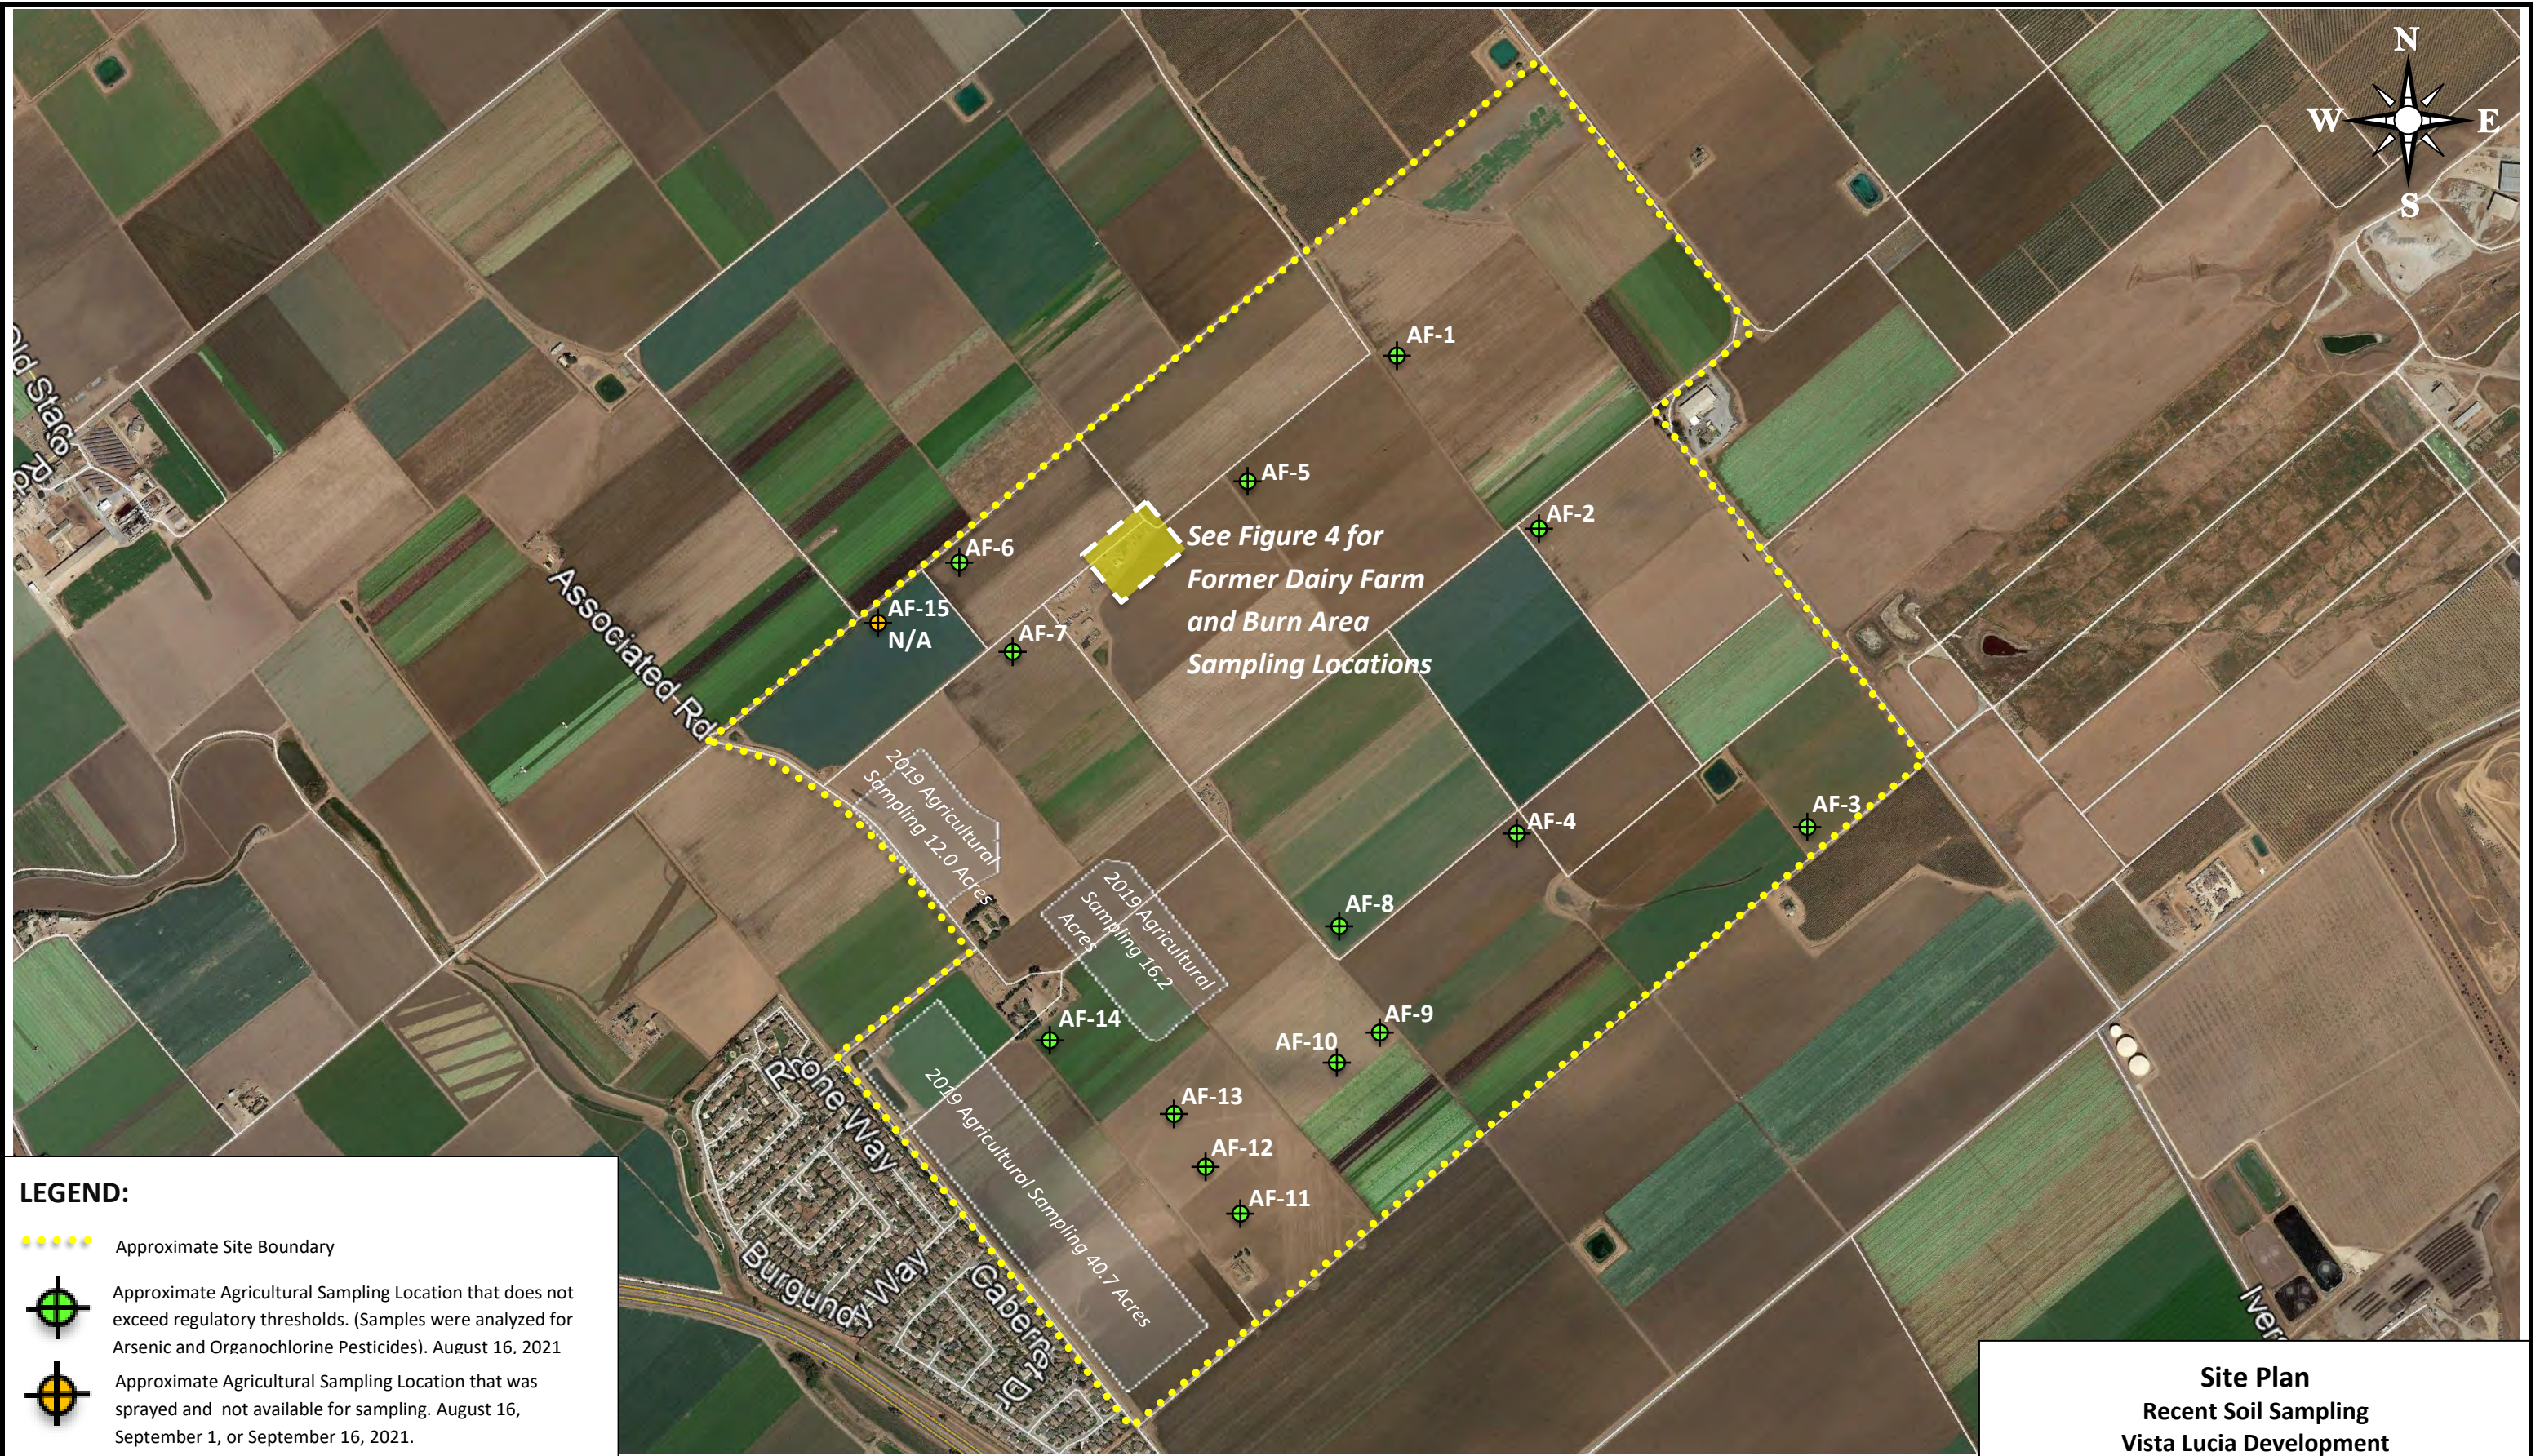
**FIGURE 1**

- Approximate Site Boundary
- Approximate Agricultural Sampling Location that does not exceed regulatory thresholds. (Samples were analyzed for Arsenic and Organochlorine Pesticides). August 16, 2021
- Approximate Agricultural Sampling Location that was sprayed and not available for sampling. August 16, September 1, or September 16, 2021.

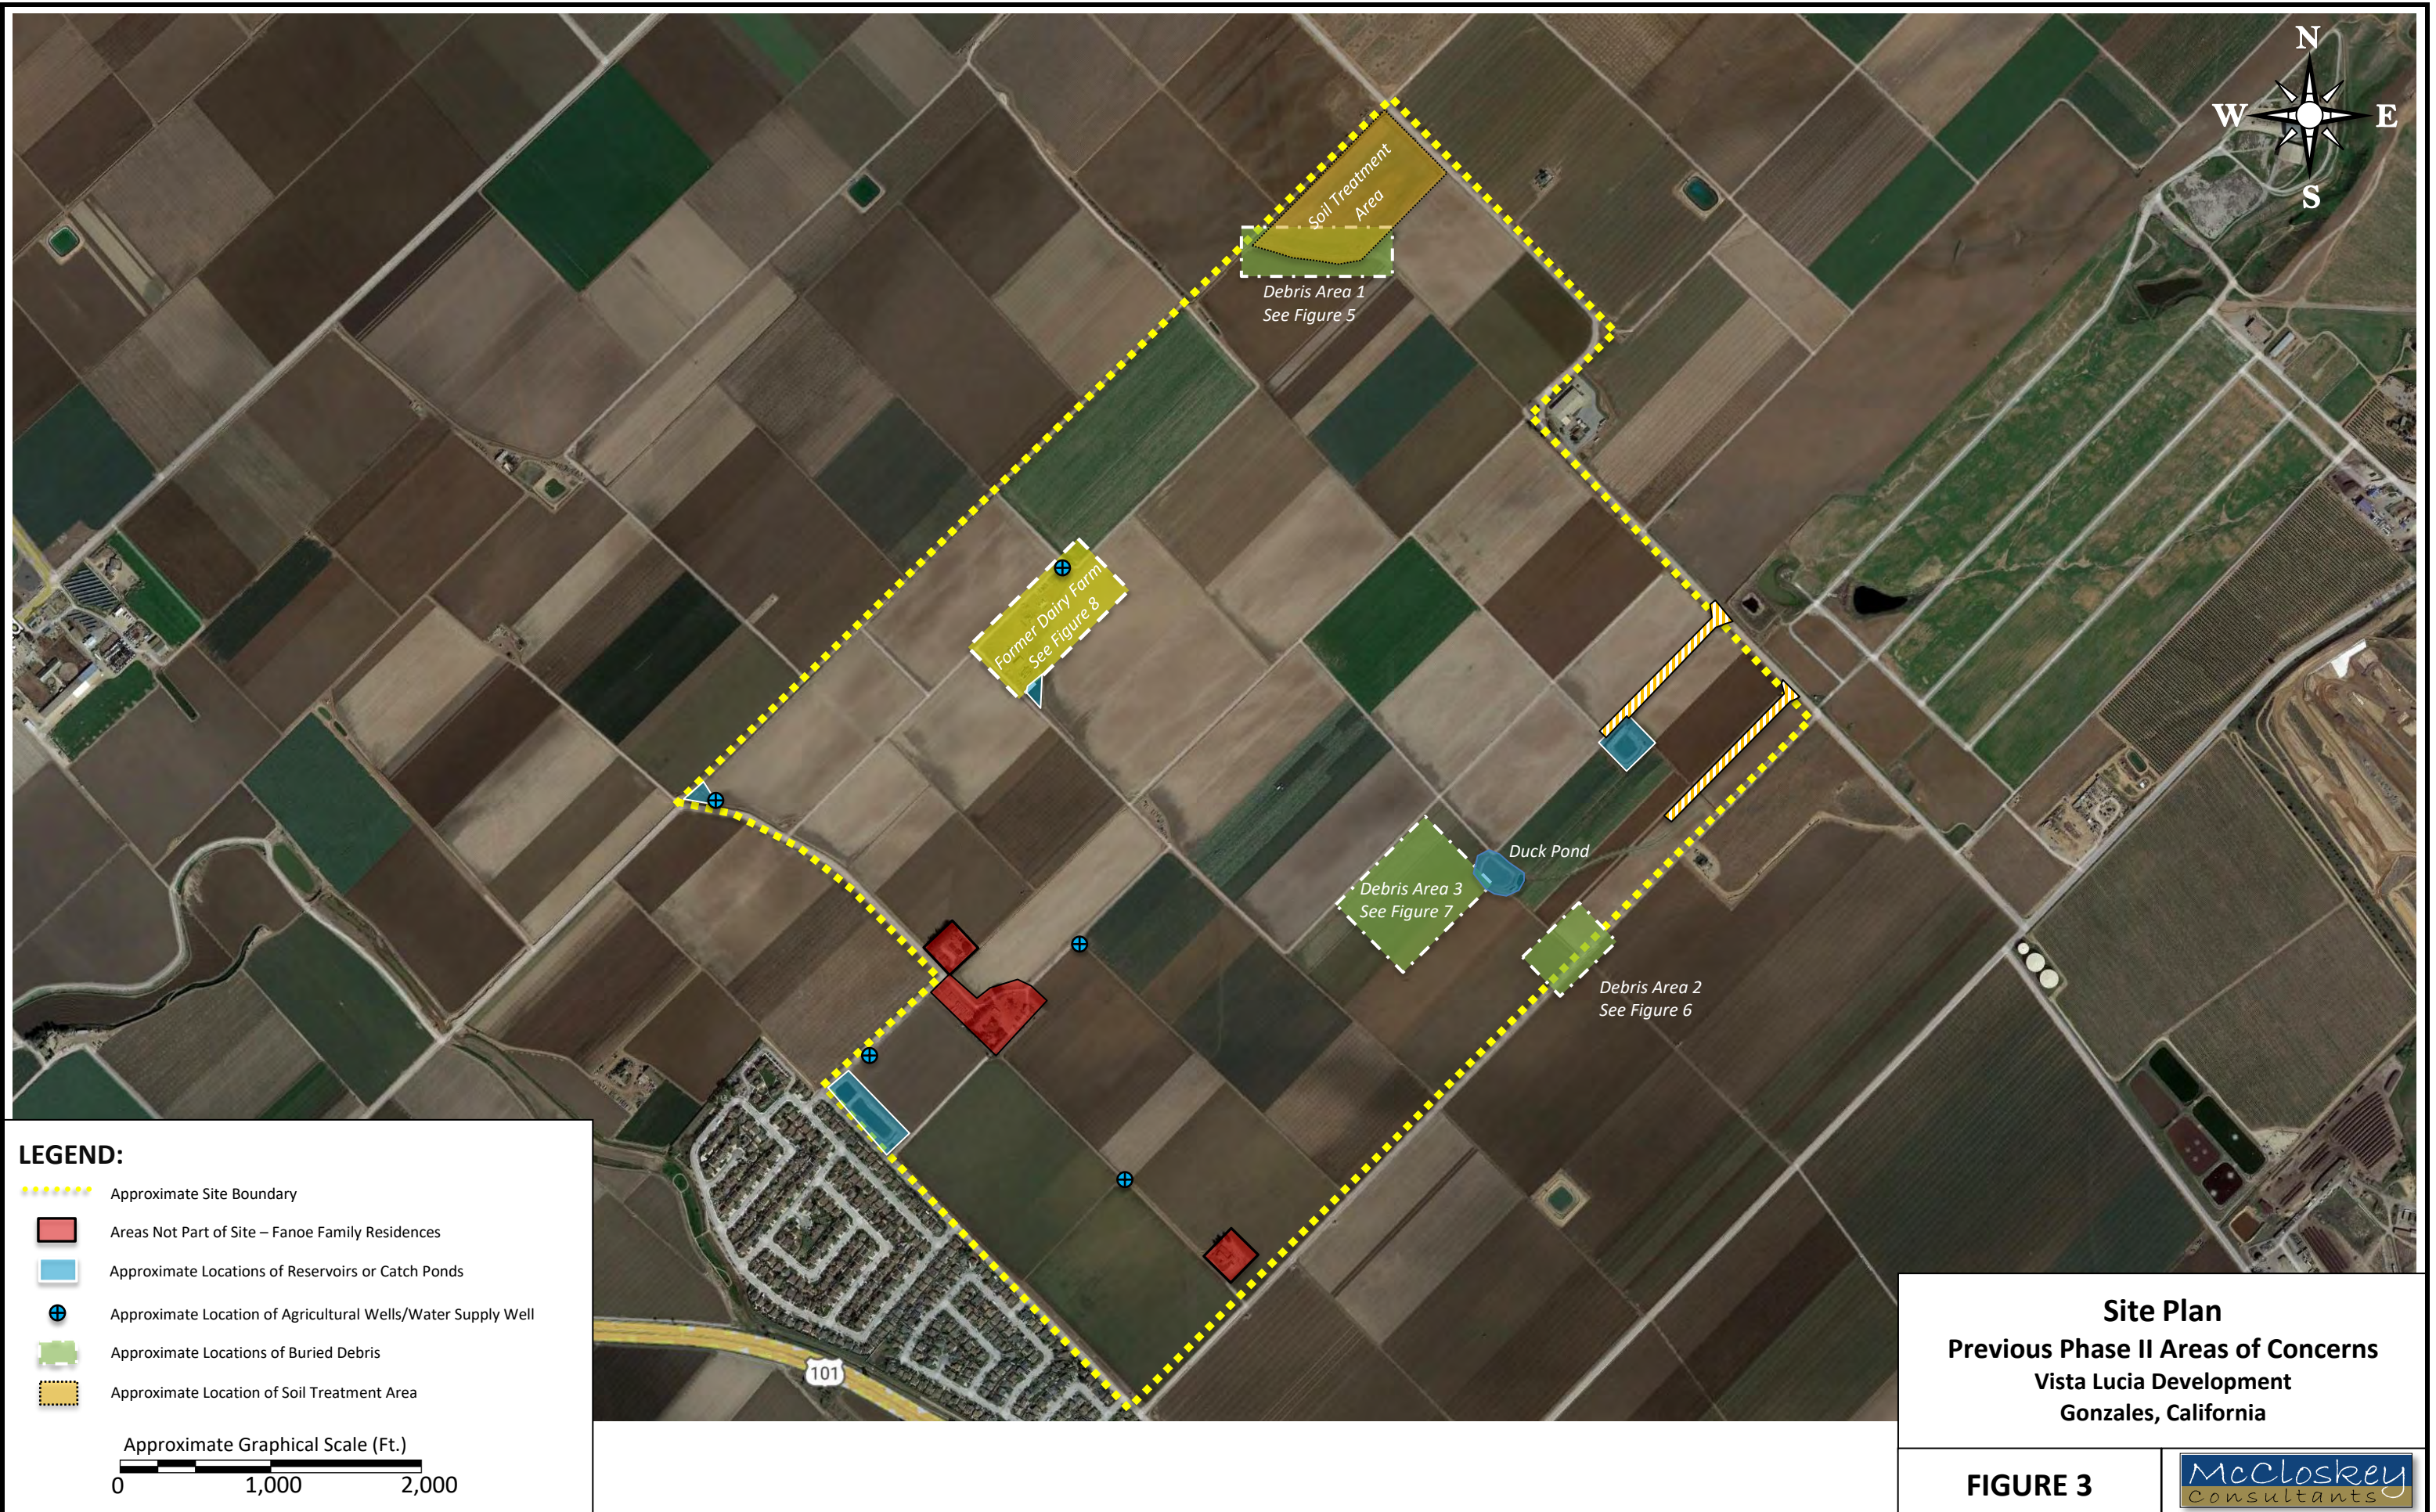
**Site Plan**  
**Recent Soil Sampling**  
**Vista Lucia Development**  
**Gonzales, California**

- - - - - Approximate Site Boundary
- Areas Not Part of Site – Fanoie Family Residences
- Approximate Locations of Reservoirs or Catch Ponds
- ⊕ Approximate Location of Agricultural Wells/Water Supply Well
- Approximate Locations of Buried Debris
- - - - - Approximate Location of Soil Treatment Area

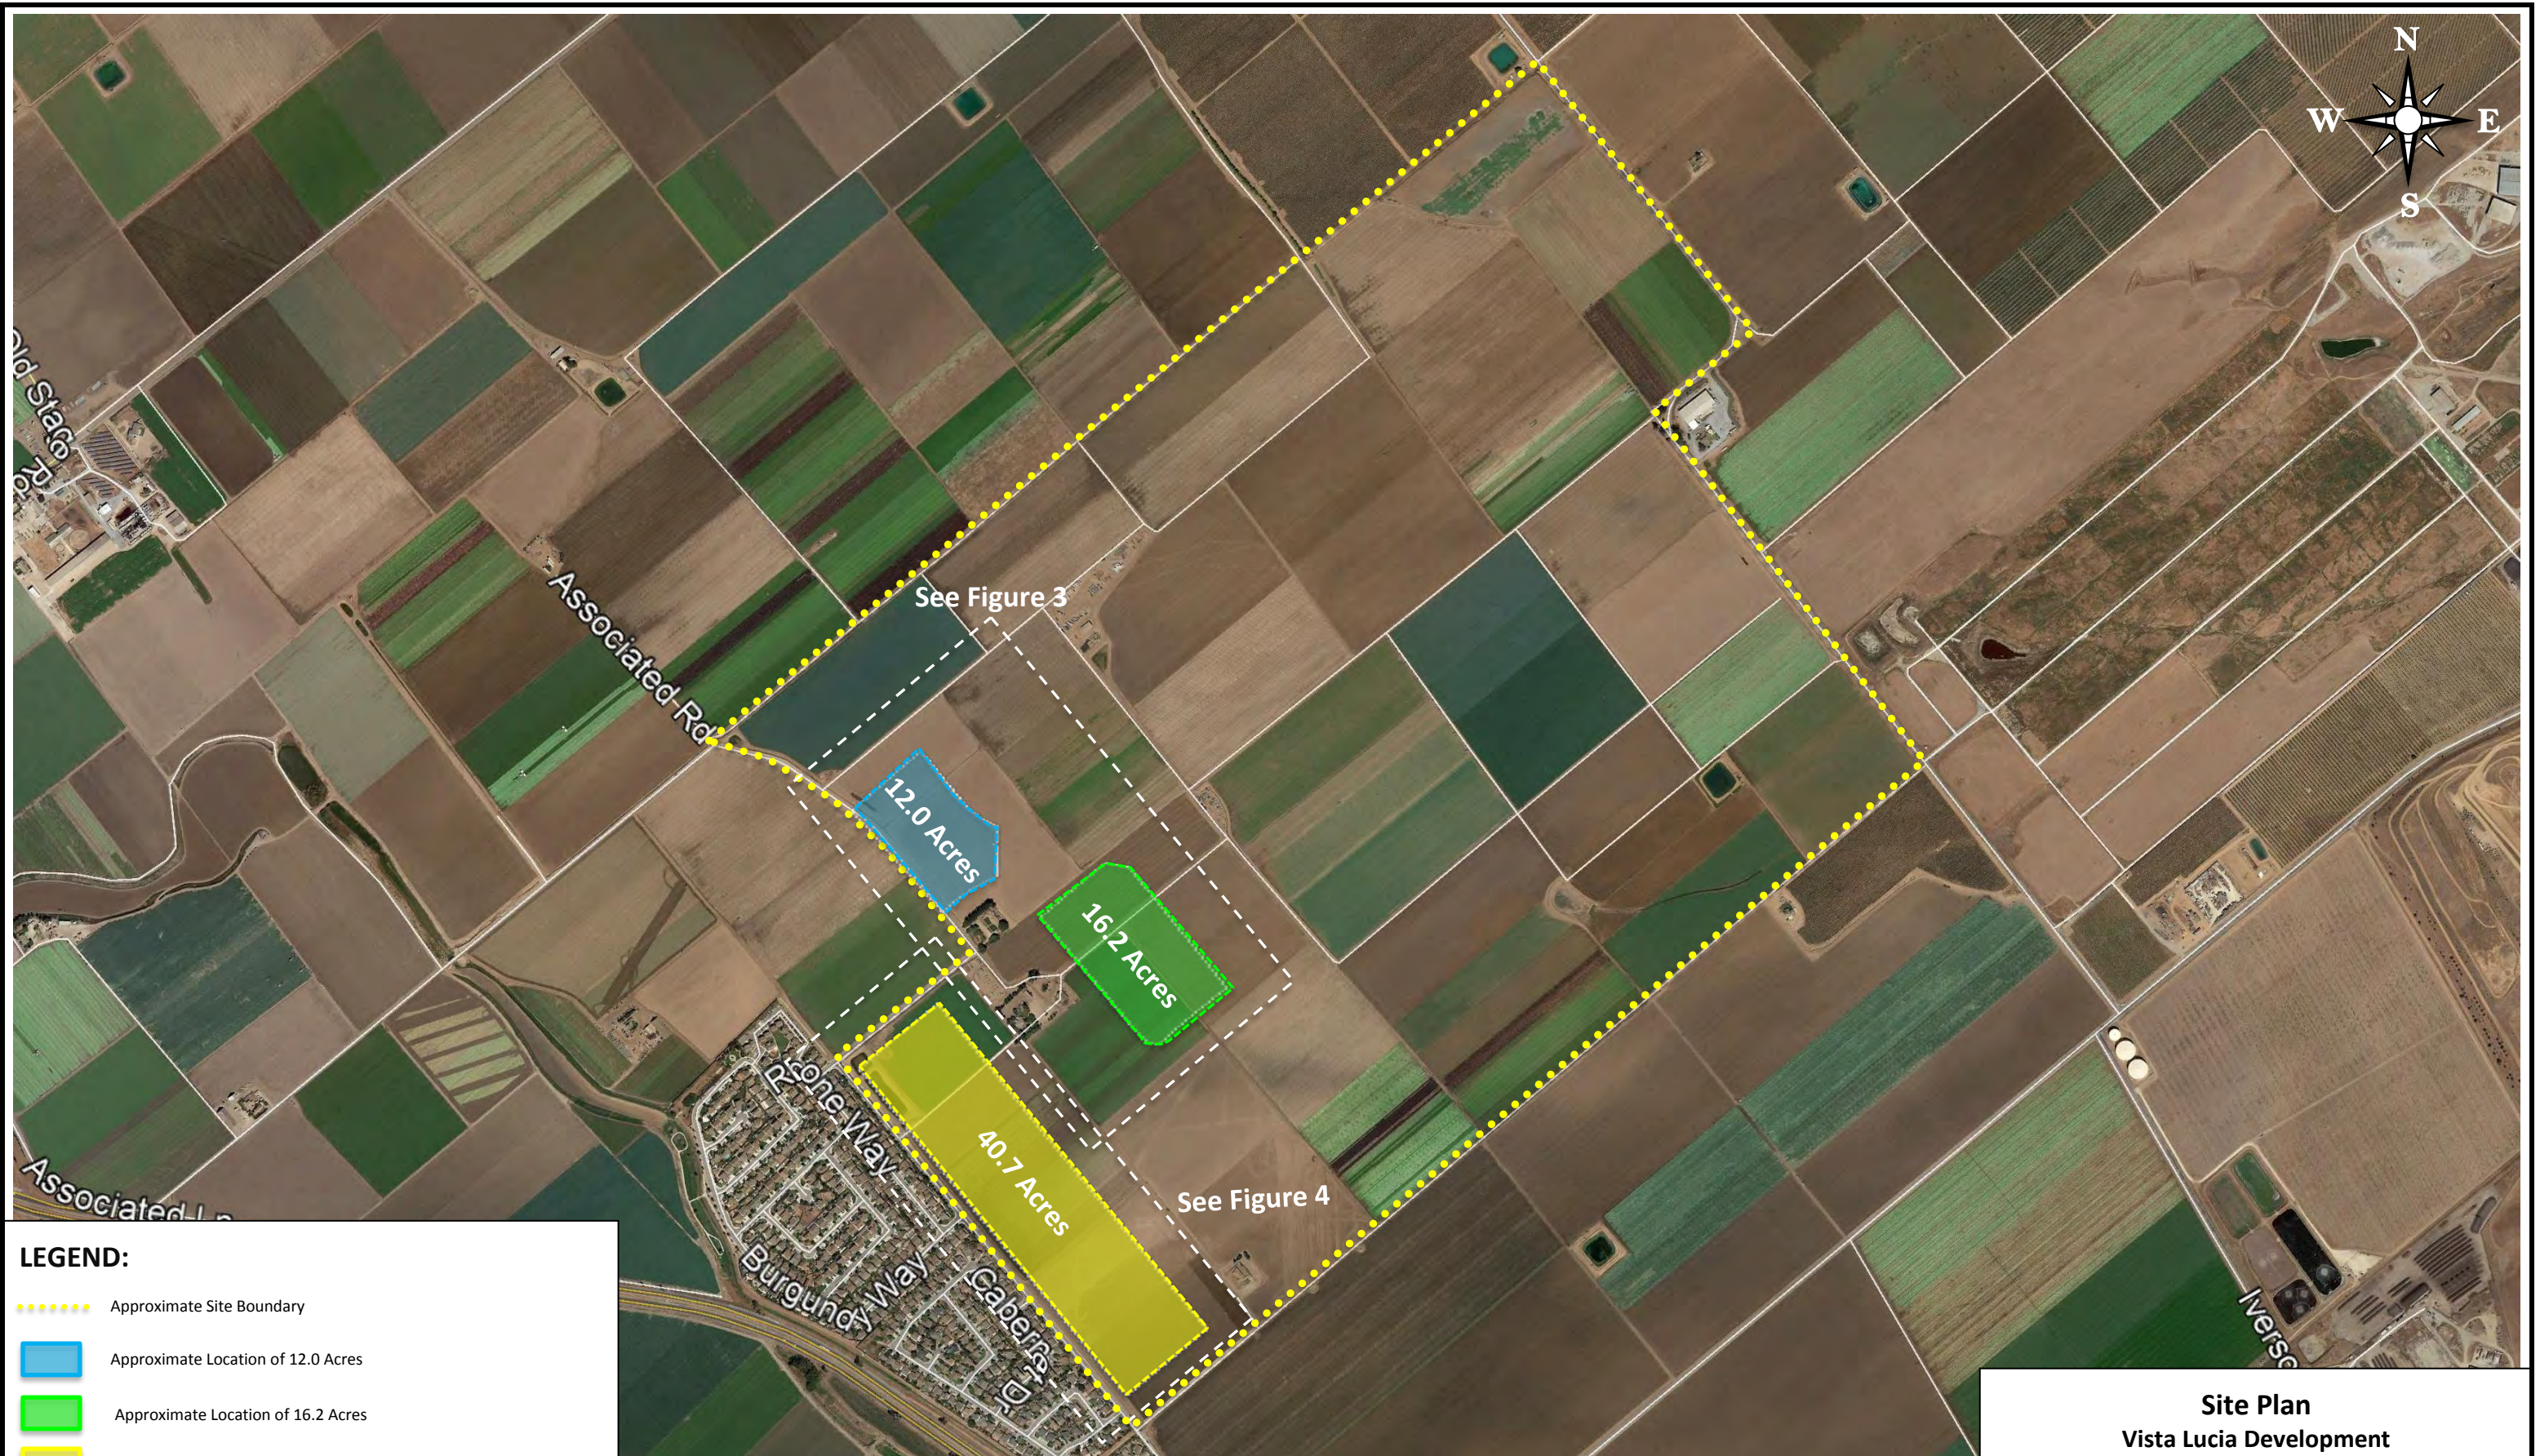
**FIGURE 1**

- Approximate Site Boundary
- Approximate Location of 12.0 Acres
- Approximate Location of 16.2 Acres
- Approximate Location of 40.7 Acres
